**REPORT NUMBER: 305-MGA-2013-005**

**SAFETY COMPLIANCE TESTING FOR FMVSS 305  
Electric Powered Vehicles: Electrolyte Spillage and Electrical Shock Protection**

**CODA AUTOMOTIVE  
2012 Coda All Electric 4-Dr Sedan  
NHTSA NUMBER: CC1005**

**PREPARED BY:  
MGA RESEARCH CORPORATION  
5000 WARREN ROAD  
BURLINGTON, WI 53105**

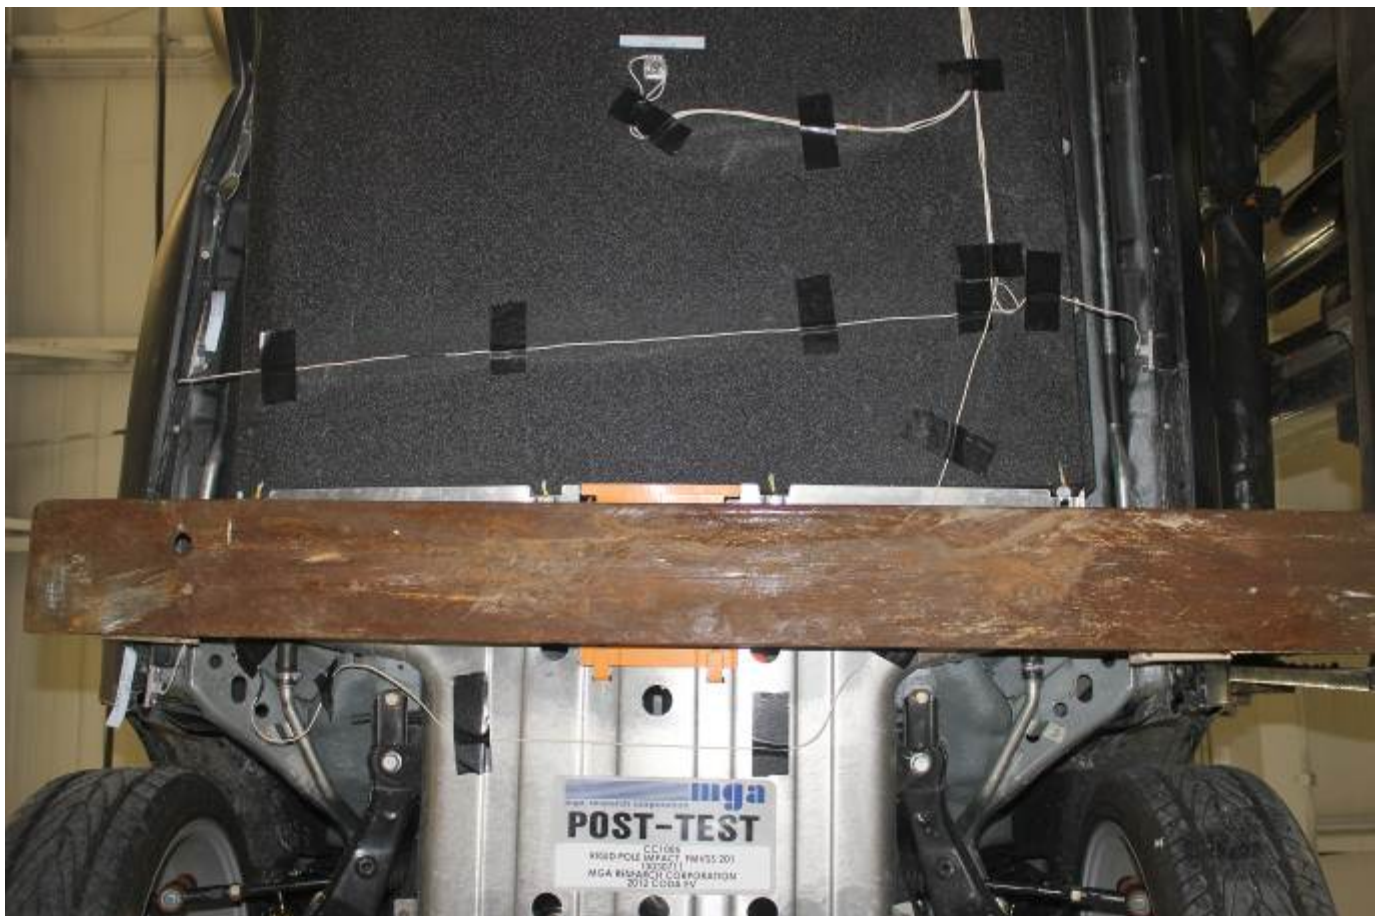
Post-Impact View of Propulsion Battery

Yes, Pass	No, Fail
All Components of Electrical Energy Storage/Conversion Device remained attached to the vehicle with at least one mounting location.	X

Yes, Fail	No, Pass
Has an outside Electric Energy Storage/Conversion Device intruded into the passenger compartment?		X

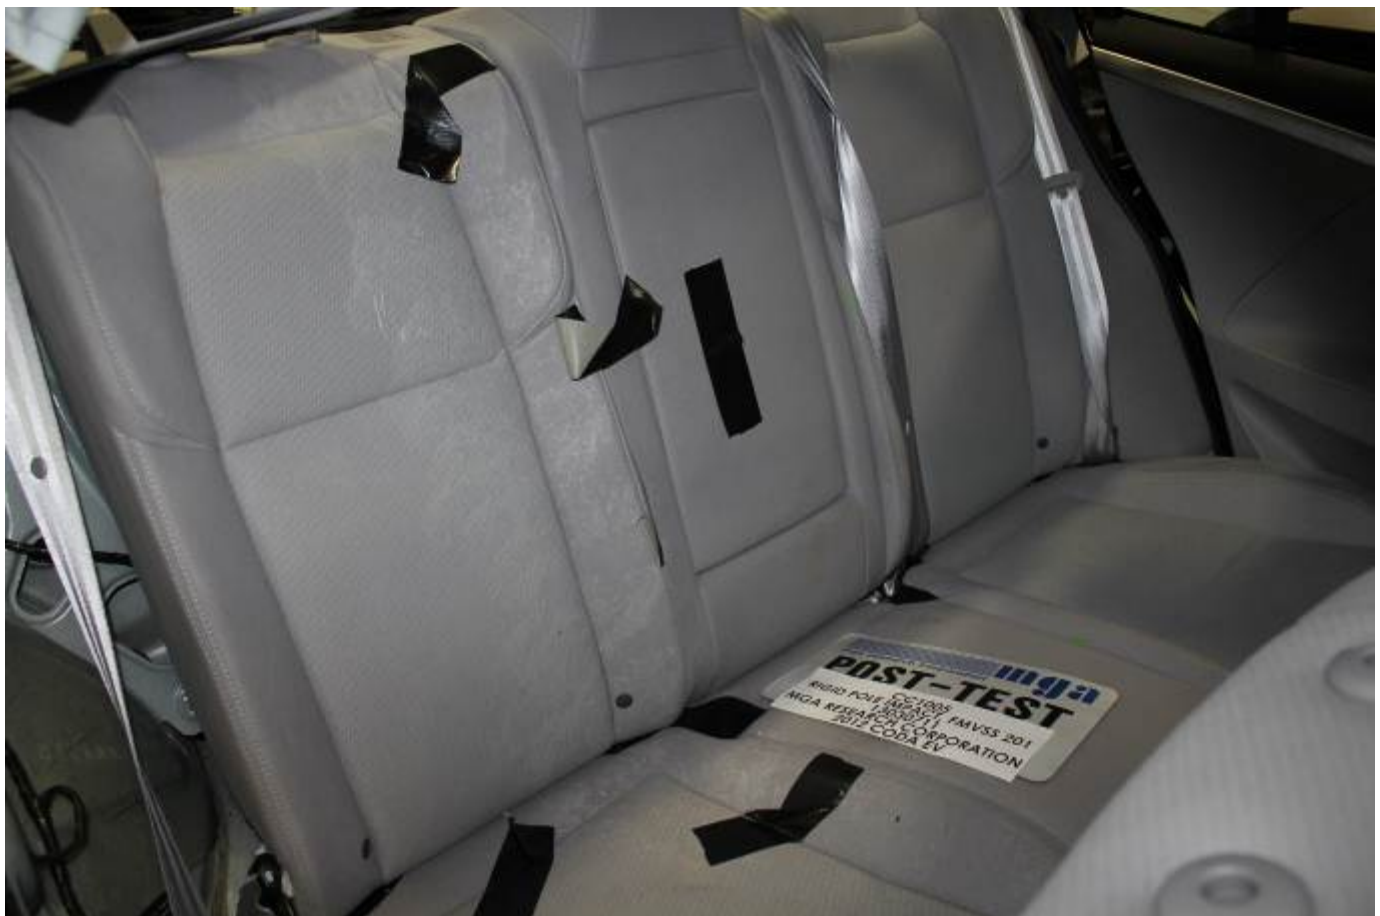
Post-Impact View of Passenger Compartment

Yes, Fail	No, Pass
Is Electric Energy Storage/Conversion Device electrolyte spillage visible in the passenger compartment?		X

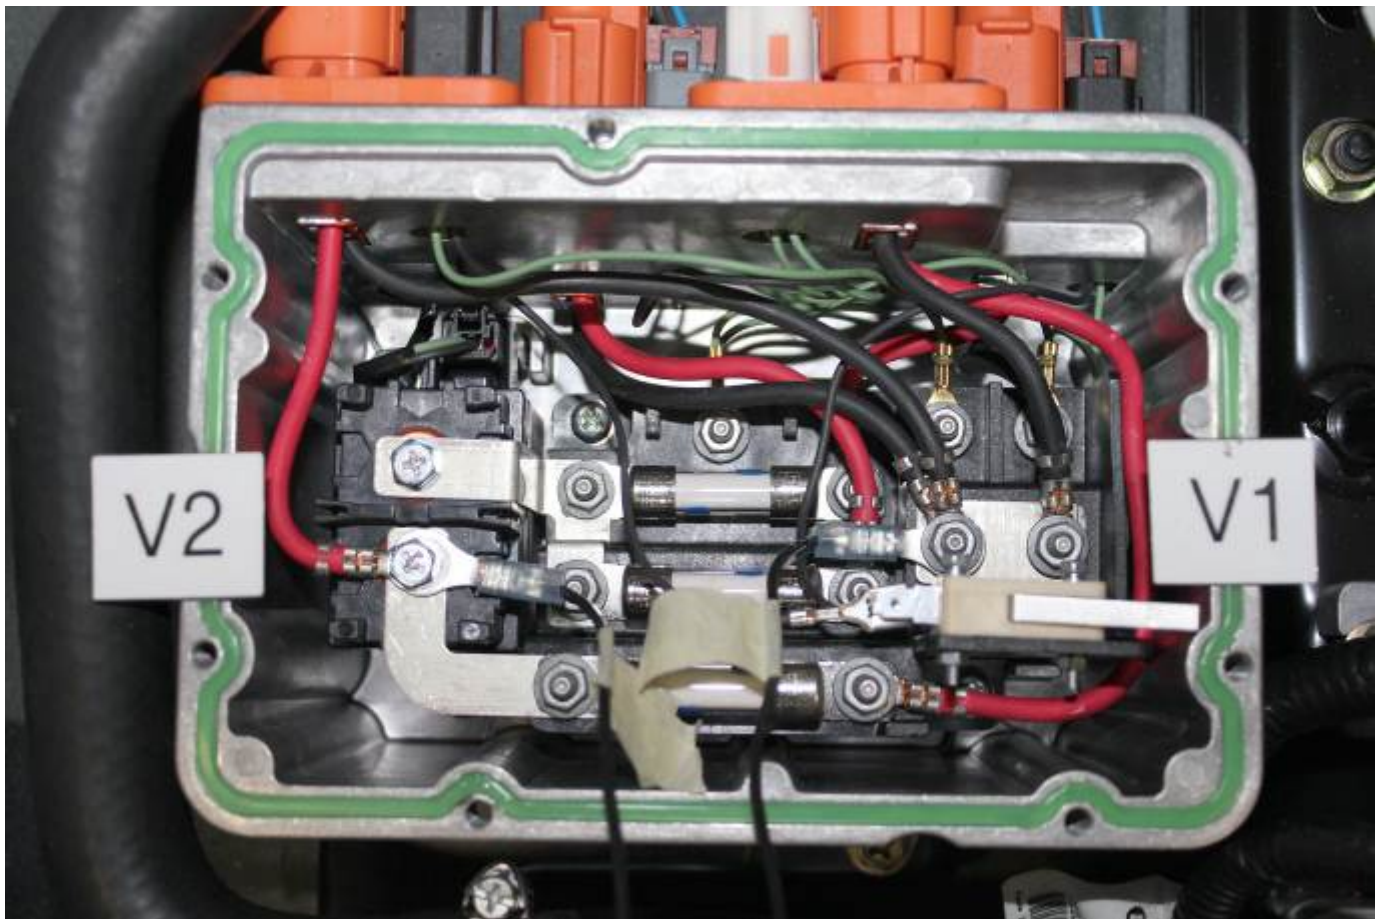
Pre-Impact View of High Voltage Lead Attached

Details of Electric Energy Storage/Conversion System Test Points:	The positive and negative test points to the battery are accessible in the trunk by removing the decking and foam protection. Attachment is then implemented at the High Voltage (HV) distribution box connector.
---	---

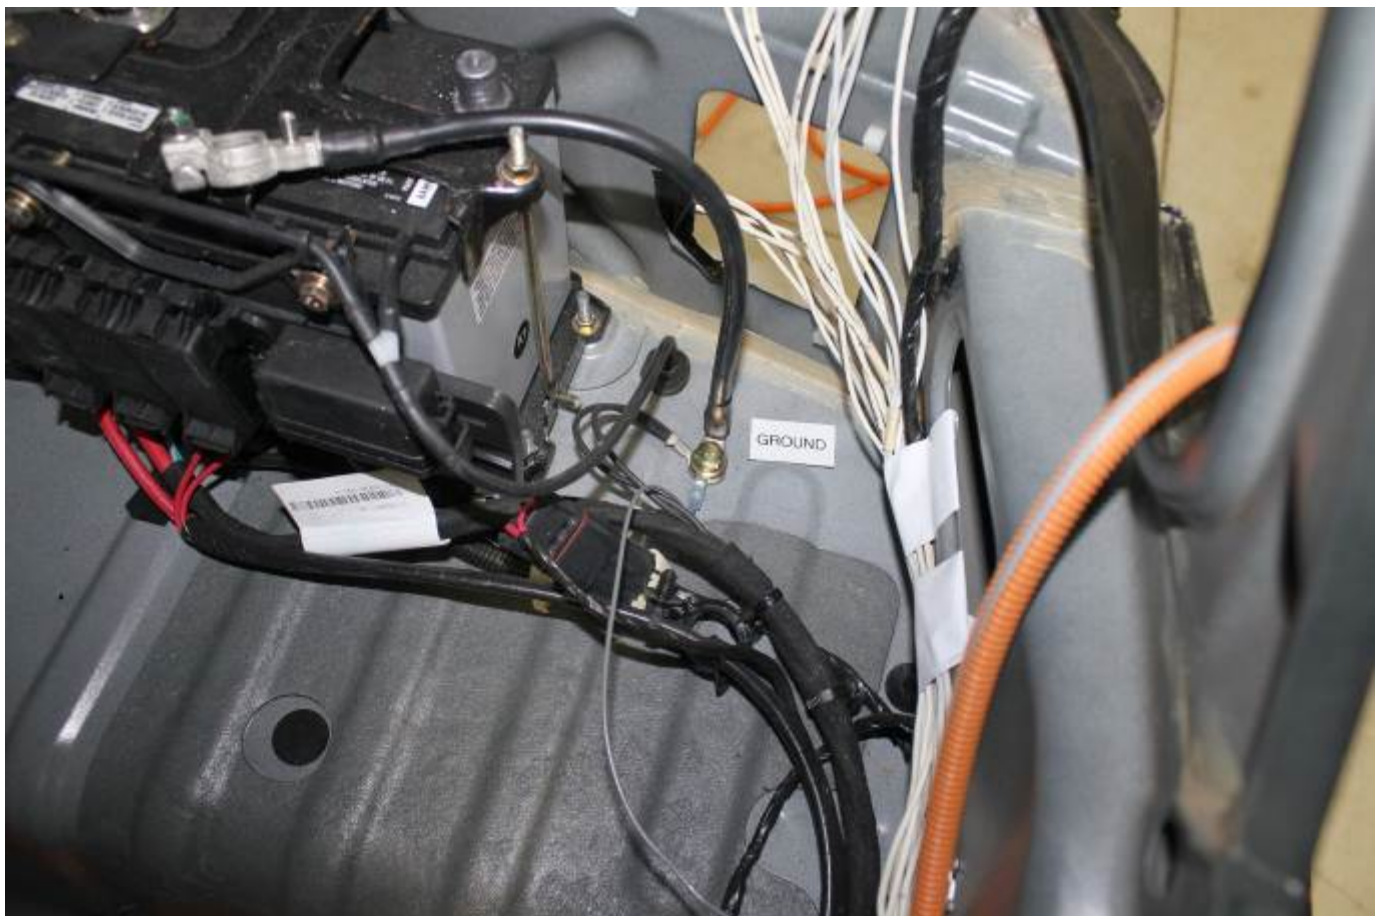
Pre-Impact View of Ground Lead Attached

Details of Vehicle Chassis Ground Point(s) & Location(s)	In cargo area, attached to 12V chassis ground.
--	--

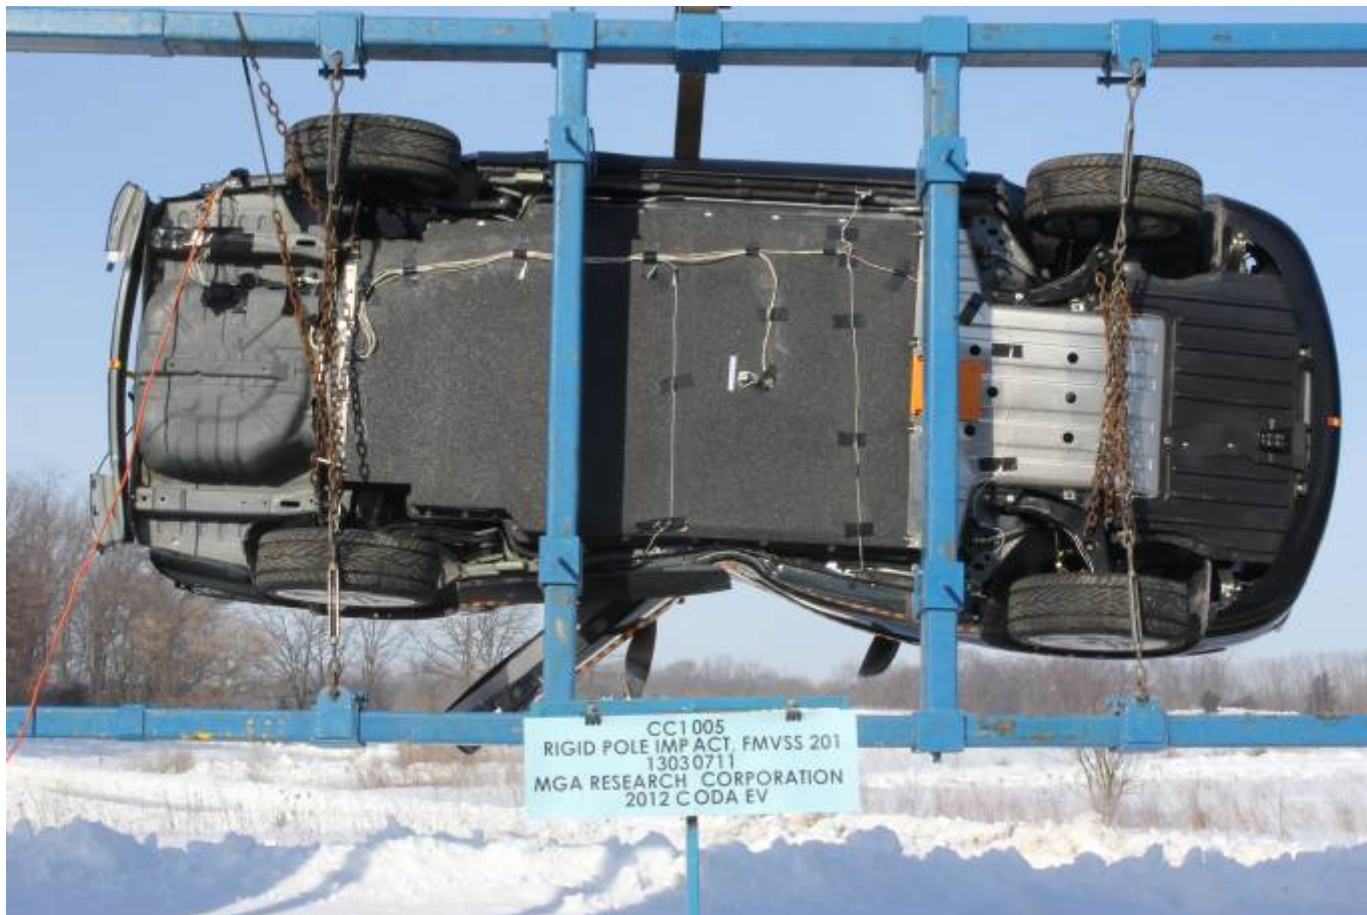
FMVSS No. 305 Static Rollover at 90°

Rollover Stage	Electric Energy Storage/Conversion Device Electrolyte Spillage (L)	Spillage Location
0° to 90°	0	Not Applicable
90° to 180°	0	Not Applicable
180° to 270°	0	Not Applicable
270° to 360°	0	Not Applicable

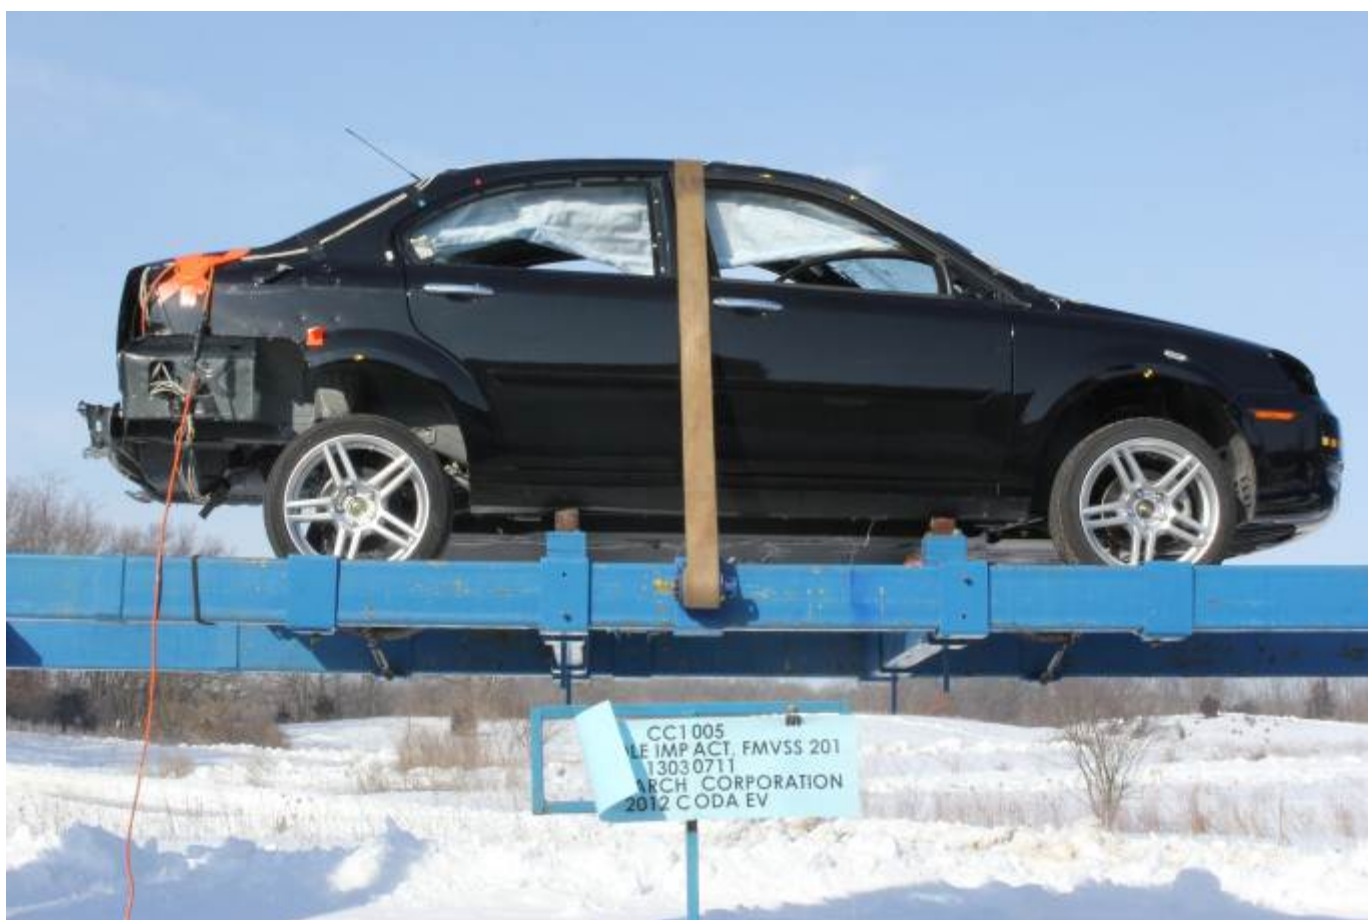
FMVSS No. 305 Static Rollover at 360°

Total Spillage: 0 L

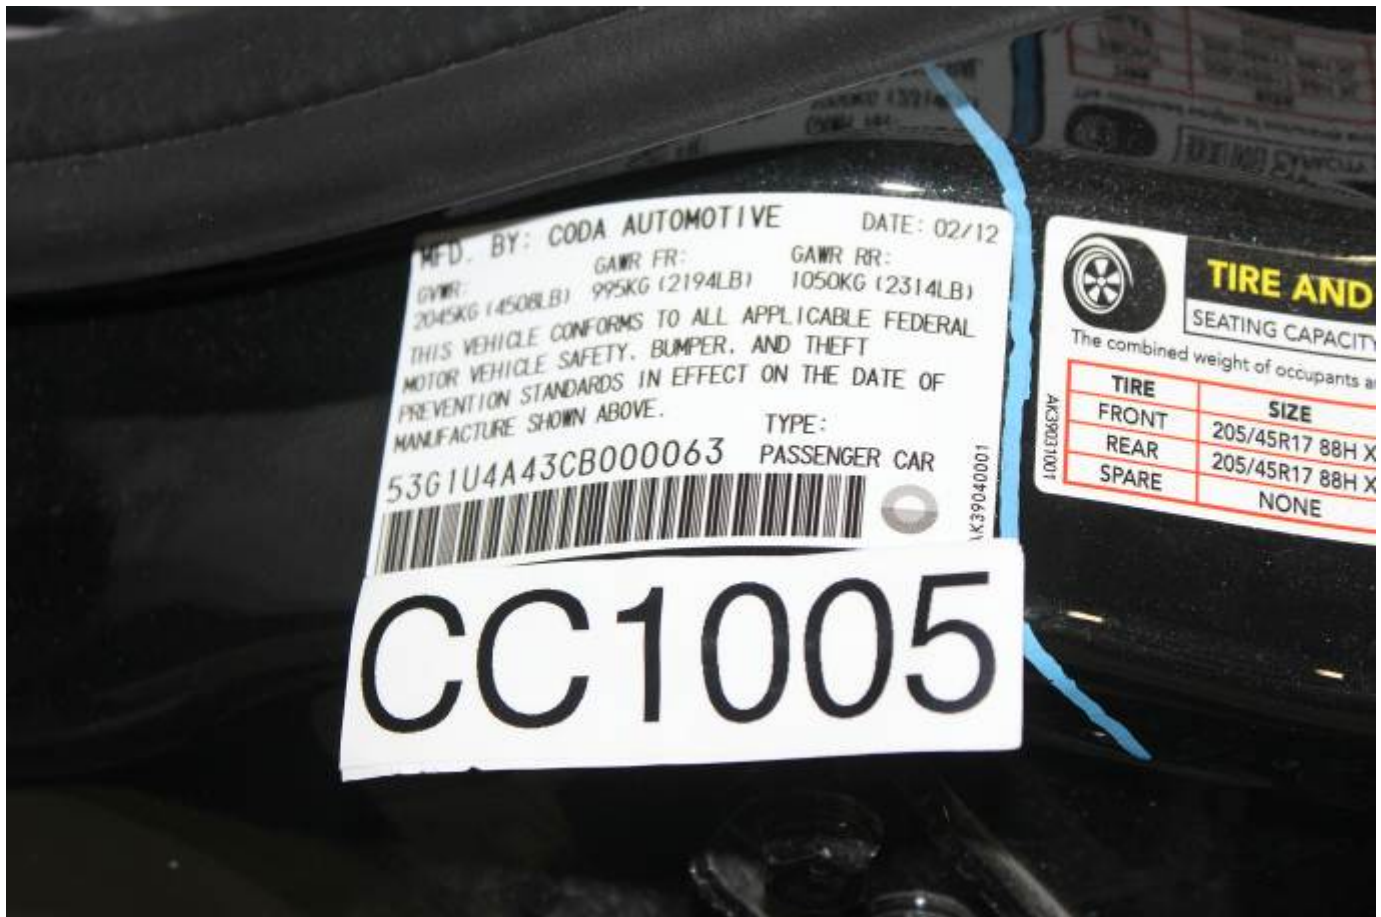
Vehicle's Certification Label

Manufactured By	CODA AUTOMOTIVE	GVWR (kg)	2045
Date of Manufacture	02/12	GAWR Front (kg)	995
VIN:	53G1U4A43CB000063	GAWR Rear (kg)	1050

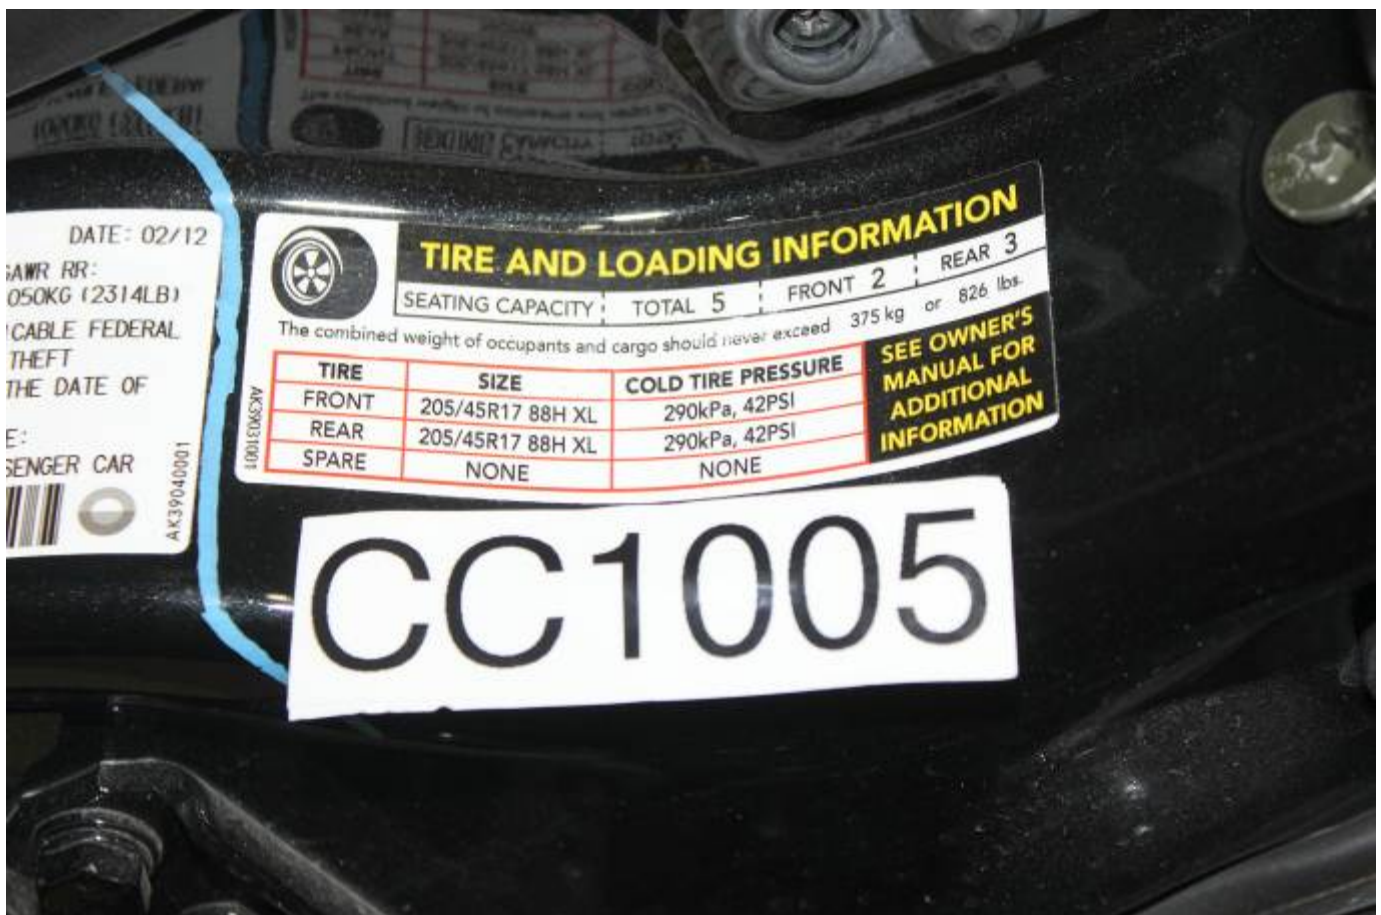
Vehicle's Tire Information Placard or Label

Measured Parameter	Front	Rear
Location of Placard of Vehicle	Left Side B-Post	
Recommended Tire Size	205/45R17	205/45R17
Recommended Cold Tire Pressure	290 kPa	290 kPa
Size of Tires on Test Vehicle	205/45R17	205/45R17
Type of Spare Tire	None
